CHAPTER V

GEOLOGY AND SUBSIDENCE

2008 PRE-SUBSIDENCE SURVEY
LIFE OF MINE PANELS

**Pre-subsidence Survey
Prior to Full Extraction at Panels
1 – 4 North,
1 – 5 and 7 – 13 West,
8 South, and
5 West Mains**

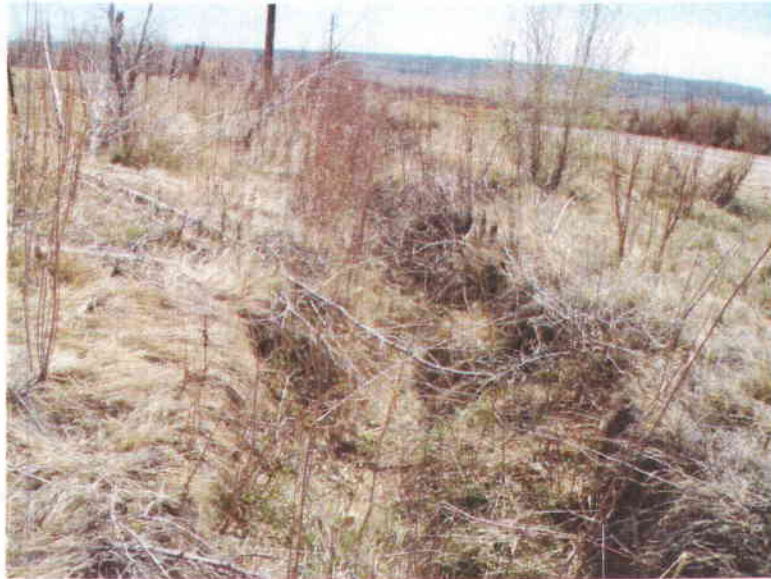
Feature 72. Irrigation Ditch. This feature has been updated from the Valley Engineering (1980) report. This ditch has earthen banks, is approximately three feet deep, and ranges from five to eight feet wide. There was no water within the ditch when it was surveyed in May 2008, but moist soil in its bottom suggested that it had been used recently. Water within the ditch flows from west to east until it reaches the paved road. From this point, water is diverted to the south through a culvert under the gravel road, and then east again under the paved road.

Feature 72. Irrigation Ditch. Looking east.

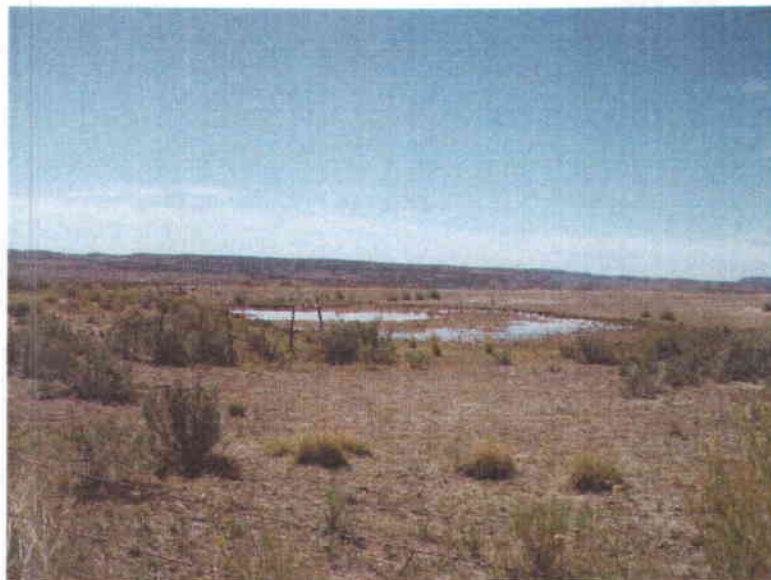
Feature 73. Pond. This feature has been updated from the Valley Engineering (1980) report. The pond is approximately 100 feet in diameter and was partially full when it was surveyed in May 2008. An approximately 5-foot tall earthen embankment runs along its downstream edge.

Feature 73. Pond. Looking southeast.

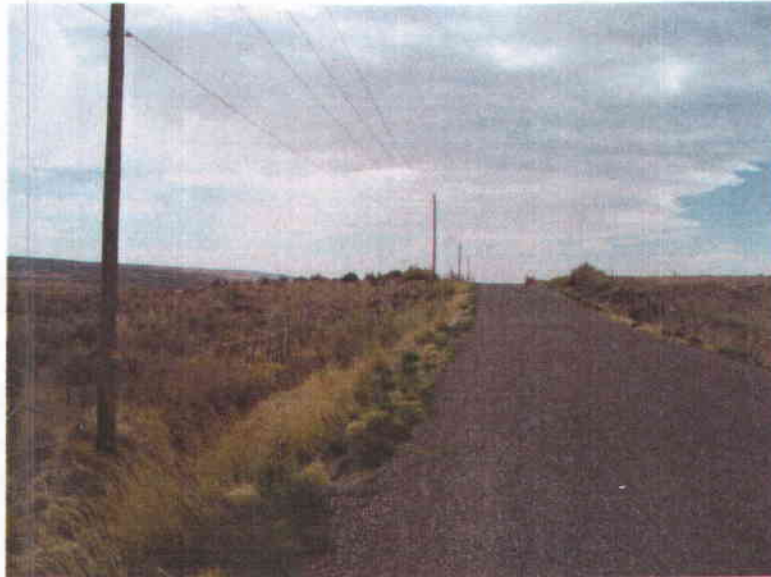
Feature 74. Irrigation Ditch. This feature is essentially unchanged from how it is described in the Valley Engineering (1980) report, which states the following: "The earthen

bank ditch is approximately 1.5 feet to 2 feet wide and 1 foot to 1.5 feet deep. Vegetation is growing along its banks.”

Feature 74. Irrigation Ditch. Looking south. The ditch is located on the left side of the road and is fed by a culvert running under the road located near where this photo was taken.

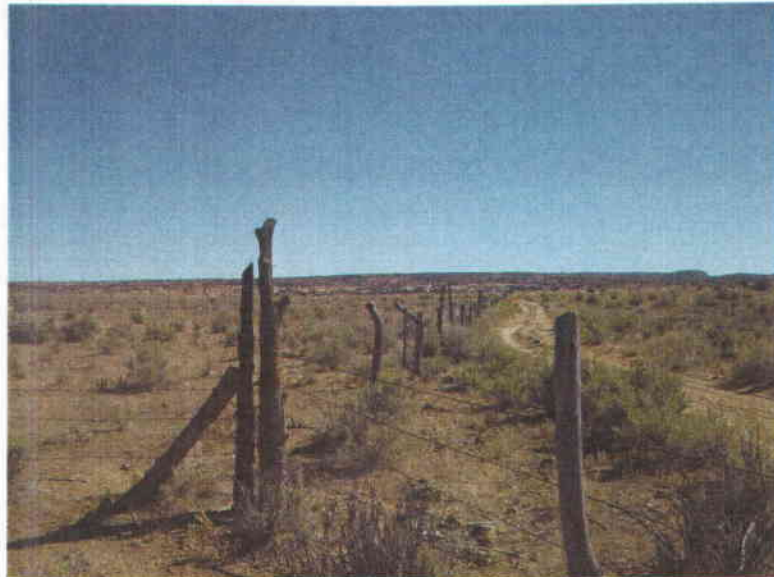
Feature 85. Dirt Road and Fences. This feature is essentially unchanged from how it is described in the Valley Engineering (1980) report, which states the following: “The road is a two-track, single lane, dirt road. The road surface consists of the natural sand and clay that is in the area, and has been compacted by vehicles that travel the road. The fences in the area are barbed wire with either natural rough cut wood posts or steel posts.” The fences are in fair to good condition.

Feature 85. Dirt Road and Fences. Looking west.

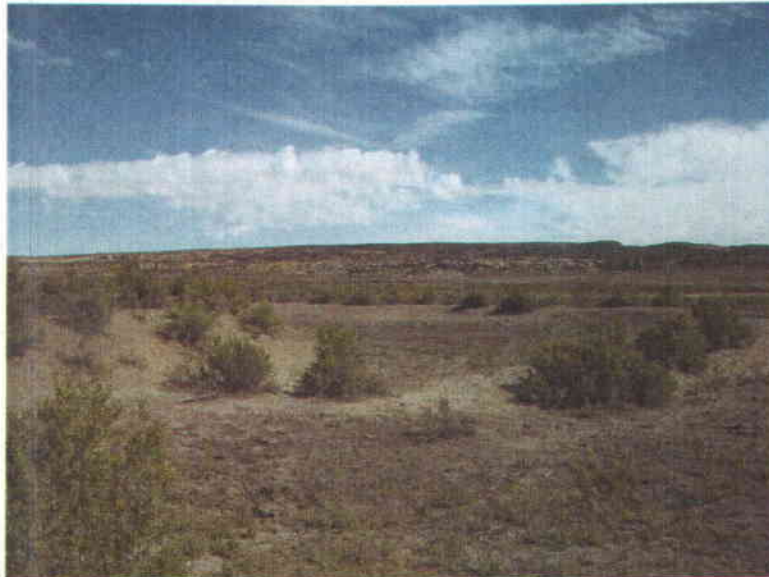
Feature 90. Ponds. The description of this feature has been updated from the Valley Engineering (1980) report. The ponds were empty during an October 2007 survey, but four earth berms were present that appeared capable of impounding water. The berms are approximately 3 feet tall. Three of the berms are clustered together in a north to south alignment, and one berm is located a few hundred feet to the northeast. A dry irrigation ditch located west of the three clustered ponds appears to serve as a water source. A dilapidated wooden corral and small shed is located just north of the three clustered ponds.

Feature 90. Ponds. Looking east.

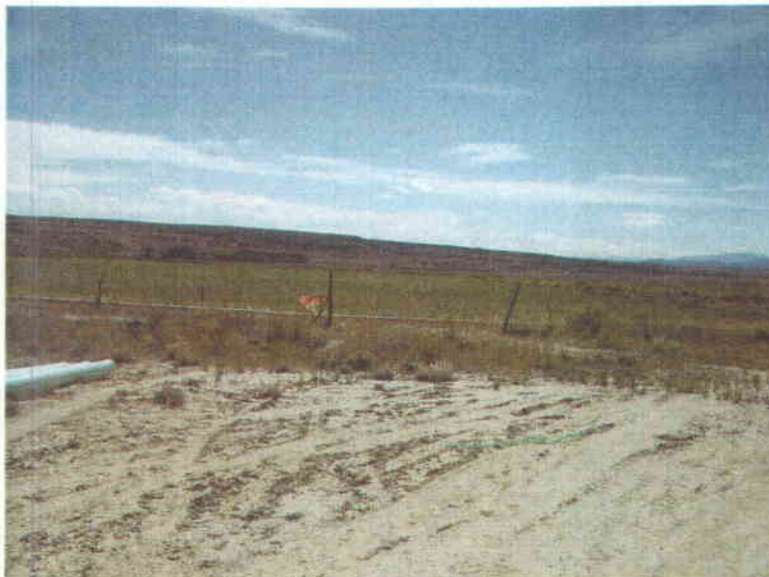
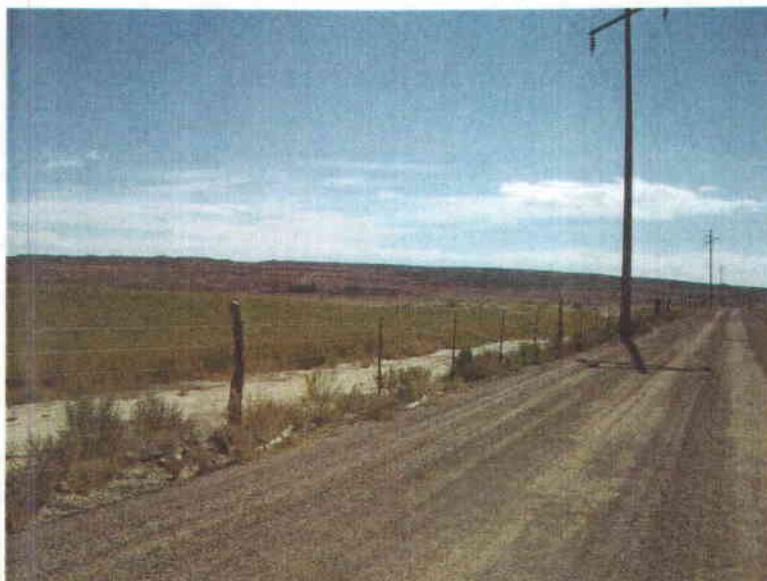
Feature 93. Irrigation Ditches and Farmland. The description of this feature has been updated from the Valley Engineering (1980) report. It contains 4 irrigated fields that comprise a total of 48 acres of cultivated land. Irrigation water flows from northwest to southeast and is supplied by the ditch running along the gravel road located east of the field.

Feature 93. Irrigation Ditches and Farm Land. Looking south.

Feature 93. Irrigation Ditches and Farm Land. Looking southeast. The farmland is located left of the road.

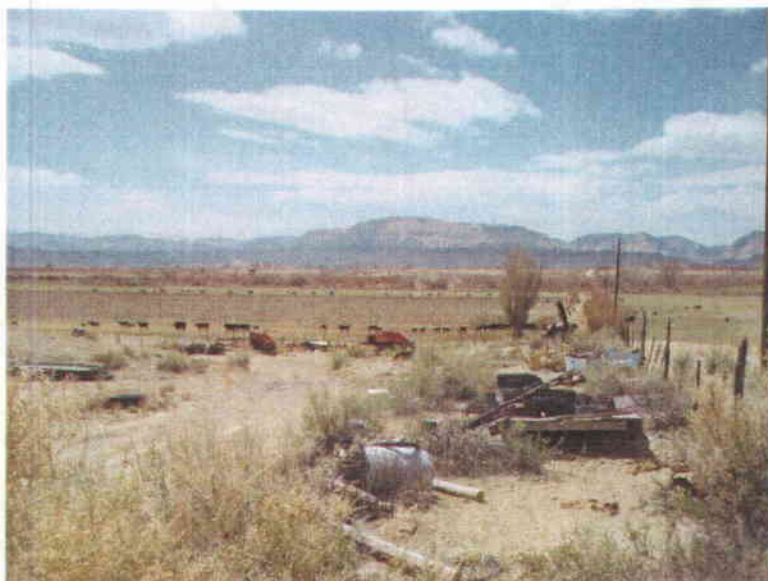
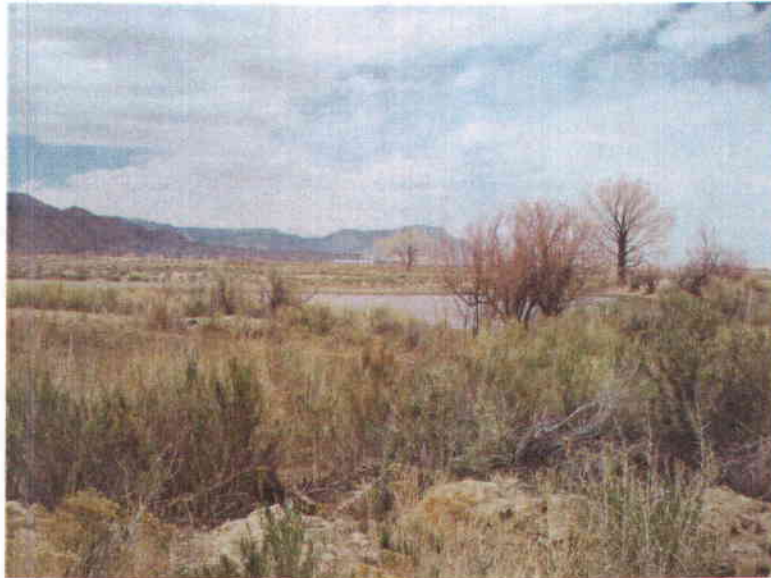
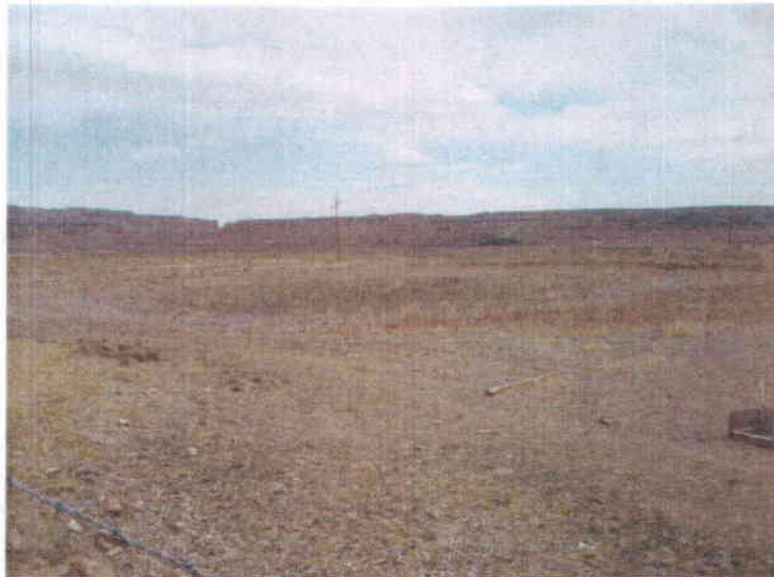
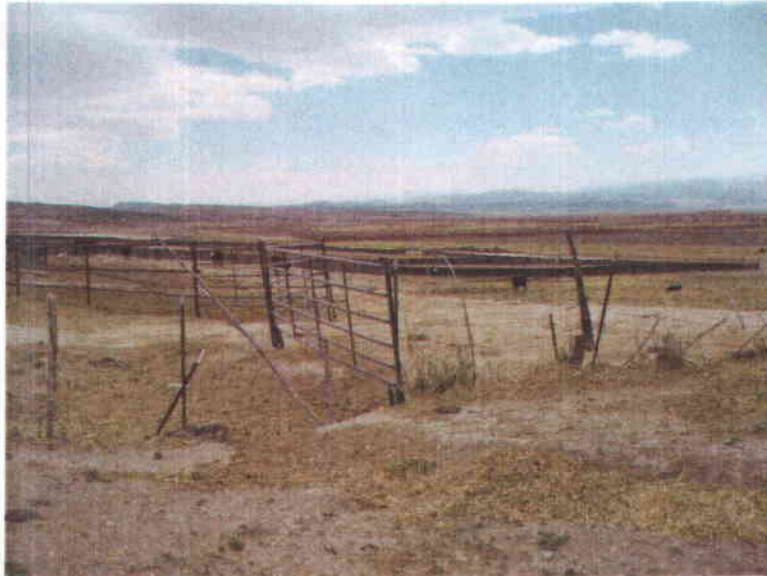
Feature 103. Farm Land, Corrals, Ponds, and Fences. The description of this feature has been updated from the Valley Engineering (1980) report. A fenced and gated hay storage area is located in the southeast corner of this feature. The fence and gate are in good condition. An unimproved dirt road (good condition) leads from the gravel road up to the hay storage area. Three small ponds are located north of the hay storage area. The two ponds that are adjacent to the hay storage area measure approximately 100 feet in diameter and are up to 5 feet deep. A larger pond measuring 400 feet by 200 feet is located about 700 feet to the northwest. Irrigated farm land and corrals surround the hay storage area. The corrals are constructed from metal tee stakes, finished and unfinished timbers, and metal tubing. They appear to be in good condition. The irrigated agricultural land consists of three fields totaling 70 acres. Irrigation is performed with a network of irrigation ditches that flow in a northwest to southeast direction as well as a buried plastic water line. The water line is 12" in diameter and runs north to south for 900 feet under the northwestern-most irrigated field of this feature. Two additional buried water lines are scheduled for construction during summer 2008. An unimproved dirt road in fair condition located about 800 feet north of the hay storage area provides additional access to the fields and corrals.

Feature 103. Farm Land, Corrals, Ponds, and Fences. Looking west at irrigated fields along Christiansen Wash.

Feature 103. Farm Land, Corrals, Ponds, and Fences. Looking north at one of the ponds.

Feature 103. Farm Land, Corrals, Ponds, and Fences. Looking southeast at one of the ponds, which was not filled when the survey was performed.

Feature 103. Farm Land, Corrals, Ponds, and Fences. Looking southwest at the fences and corrals.

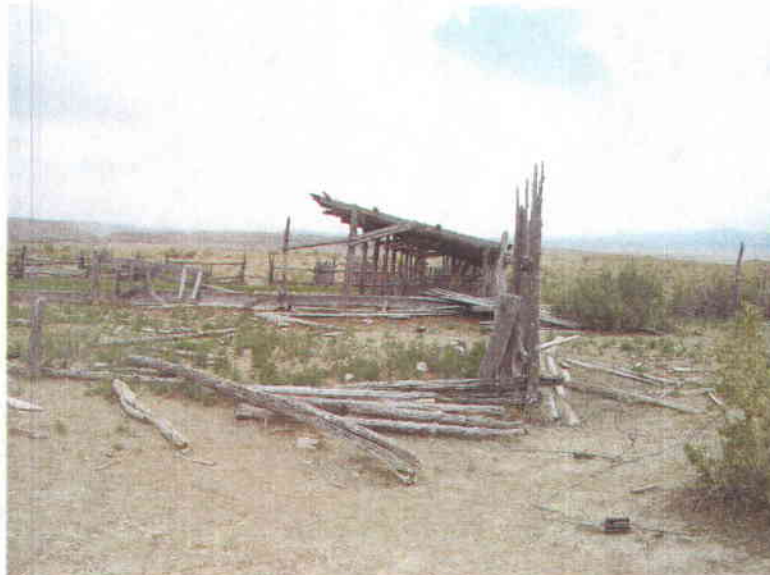
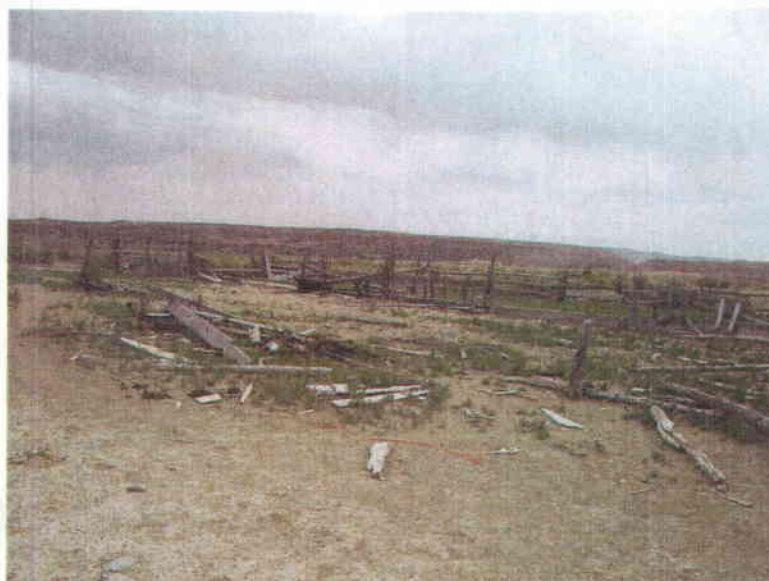
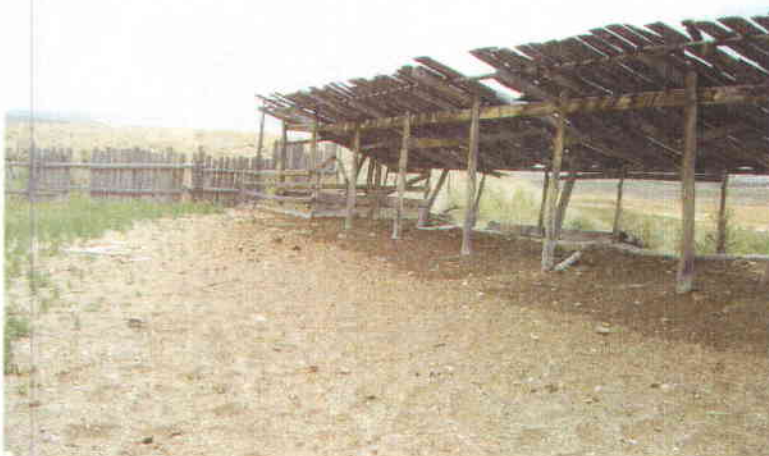
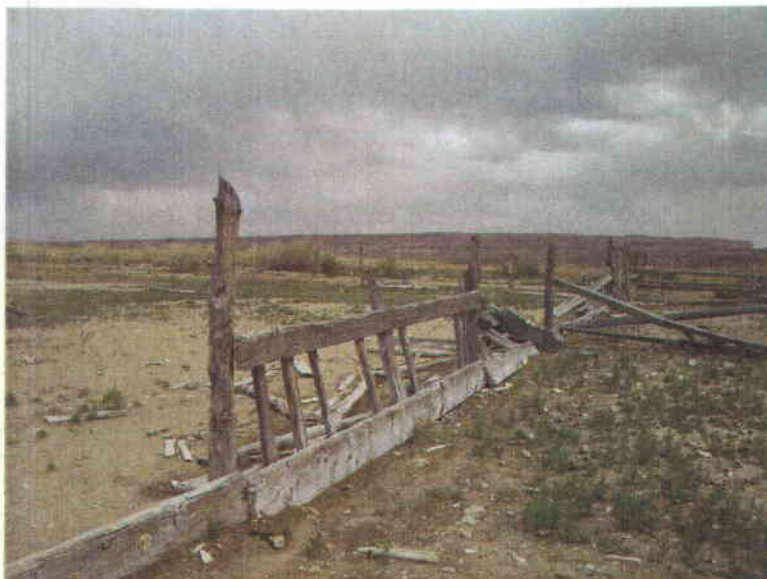
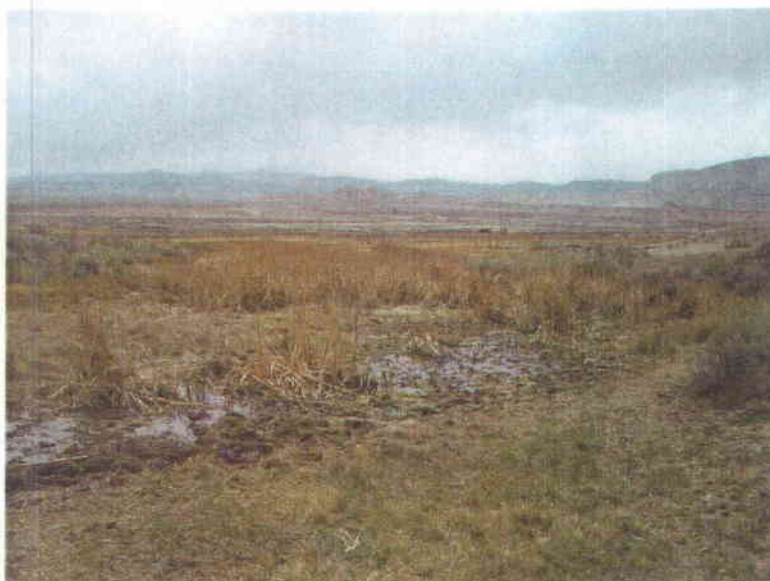
Feature 107. Corrals and Covered Shelters. The description of this feature has been updated from the Valley Engineering (1980) report. The corrals and shelters are in poor condition and are constructed of rough cut lumber and rough sawn boards. Several pieces of the fence are missing. The land slopes steeply downward just to the south of the corrals toward a broad, flat plain. During site reconnaissance, a marshy, grassy area was observed near the base of this slope. This marshy area corresponds to SP-9 on Plate VI-2/VI-2A and in the text of Chapter VI Volume 1 Section VI.A.2 (Springs and Seeps) of the Emery Mine Permit

Feature 107. Corrals and Covered Shelters. Looking south at west portion of corral and covered shelter. (Photo taken April 2007)

Feature 107. Corrals and Covered Shelters. Looking southeast at east portion of corral and covered shelter. (Photo taken April 2007)

Feature 107. Corrals and Covered Shelters. Looking southwest at covered shelter. (Photo taken April 2007)

Feature 107. Corrals and Covered Shelters. Looking east along northern edge of corral. (Photo taken April 2007)

Feature 107. Corrals and Covered Shelters. Looking southwest at marshy, grassy area below and south of the corral and covered shelters. (Photo taken April 2007)

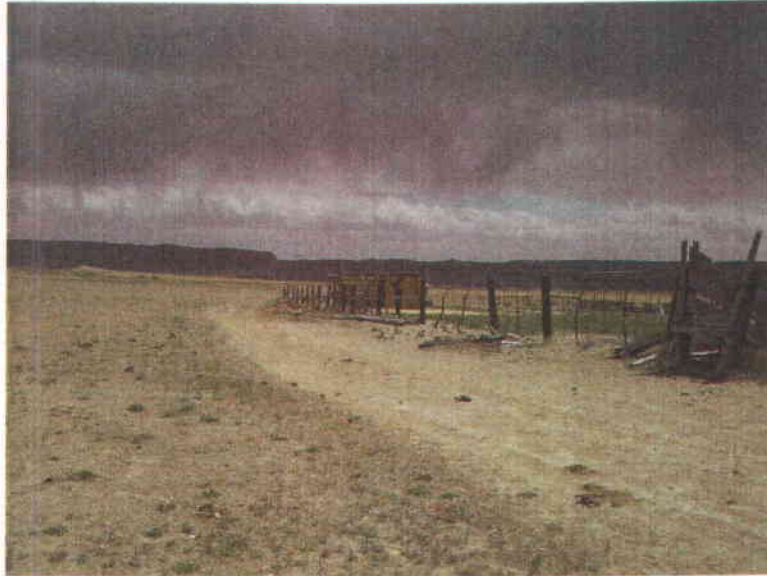
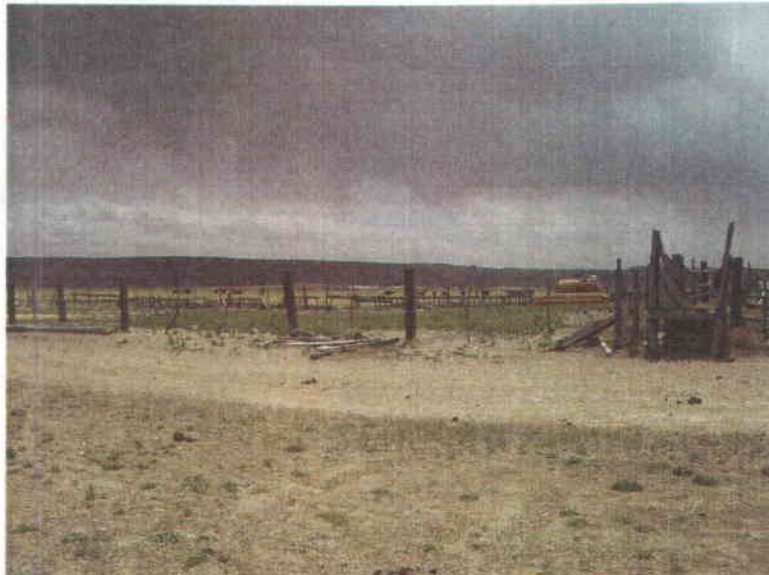
Feature 108. Corral. The description of this feature has been updated from the Valley Engineering (1980) report. This feature is in fair condition. It is constructed from square rough-cut wood posts, unfinished wood posts, and steel fencing reinforcement. Most of the corral is fenced with barbed wire. During site reconnaissance in May 2008, several hay bales were being stored in the corral, suggesting that it was being used

Feature 108. Corral. Looking southeast.

Feature 108. Corral. Looking south.

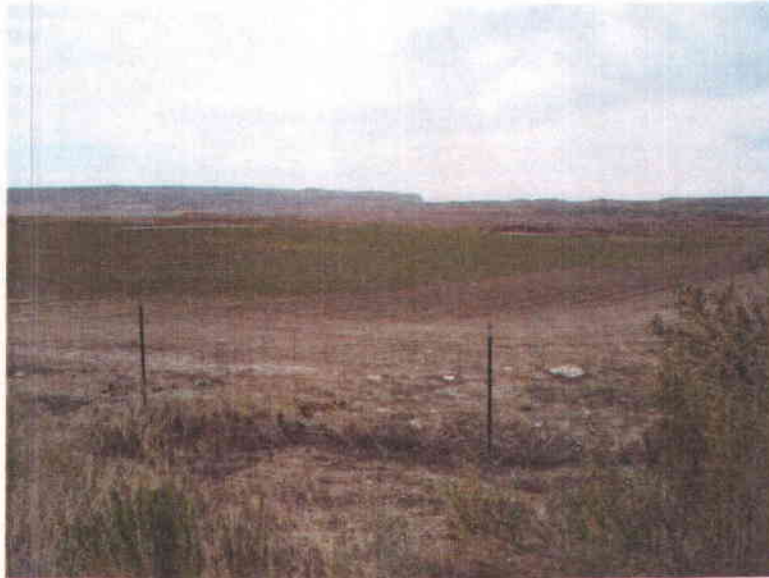
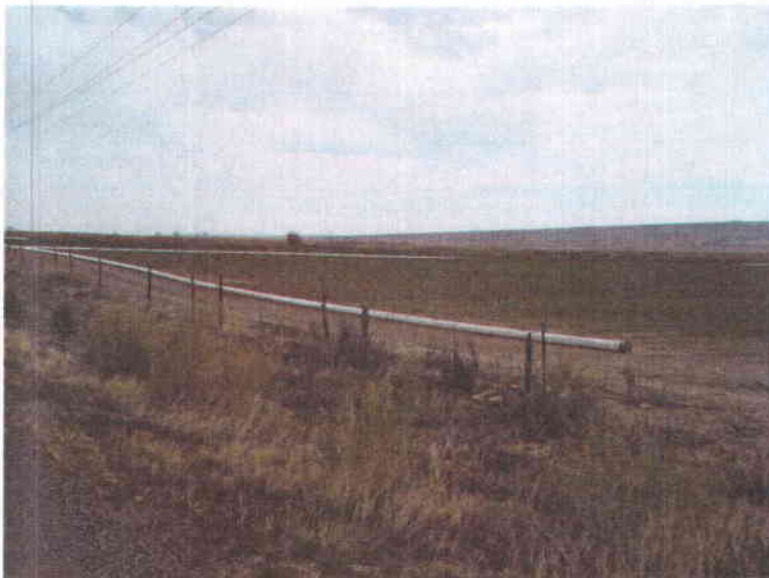
Feature 109. Farm Land. The description of this feature has been updated from the Valley Engineering (1980) report. This area is used primarily for growing alfalfa, but there are some grassland areas used for pasture. Irrigation water is conveyed to the area via a network of piping and ditches that drains to the southeast. There is one small pond that has been constructed at this feature.

Feature 109. Farm Land. Looking east.

Feature 109. Farm Land. Looking northeast.

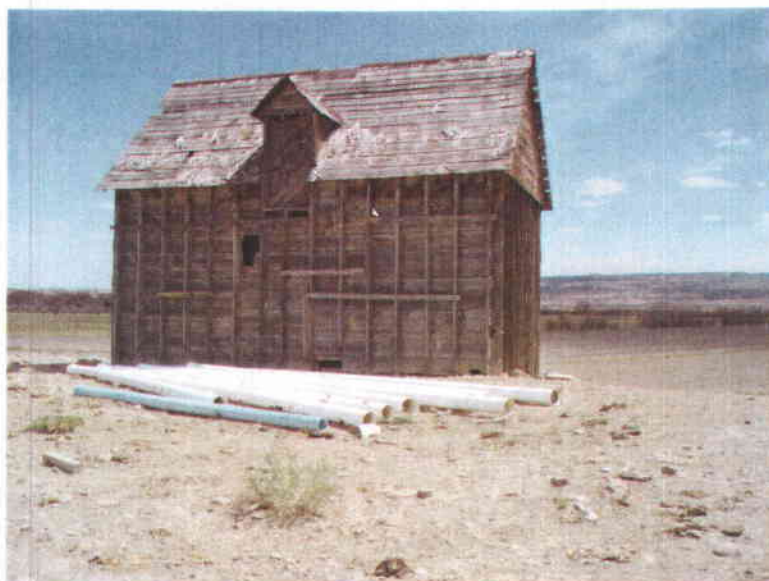
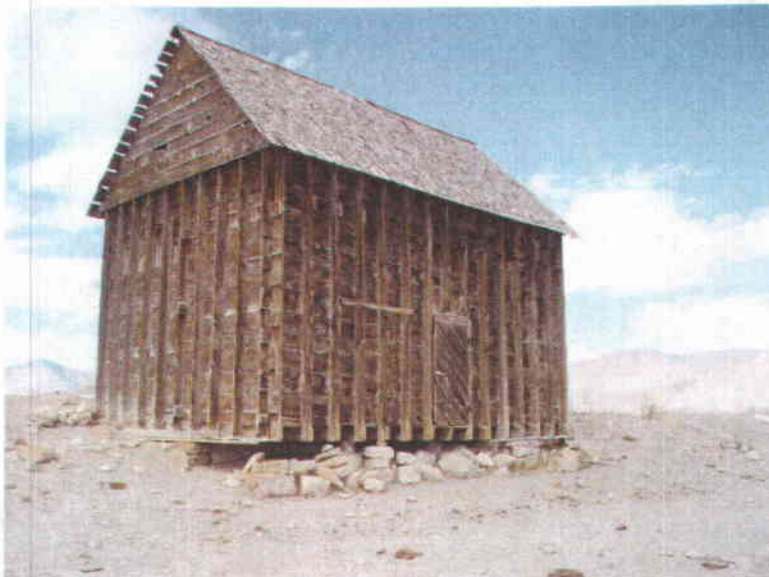
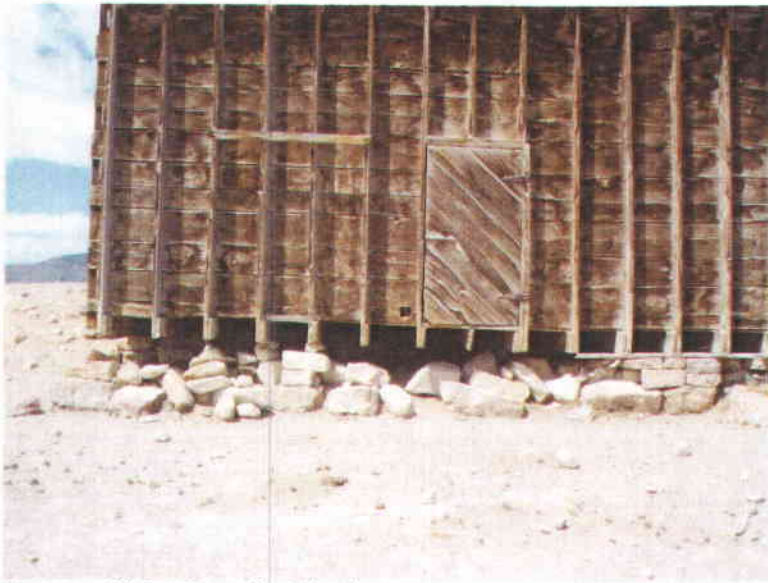
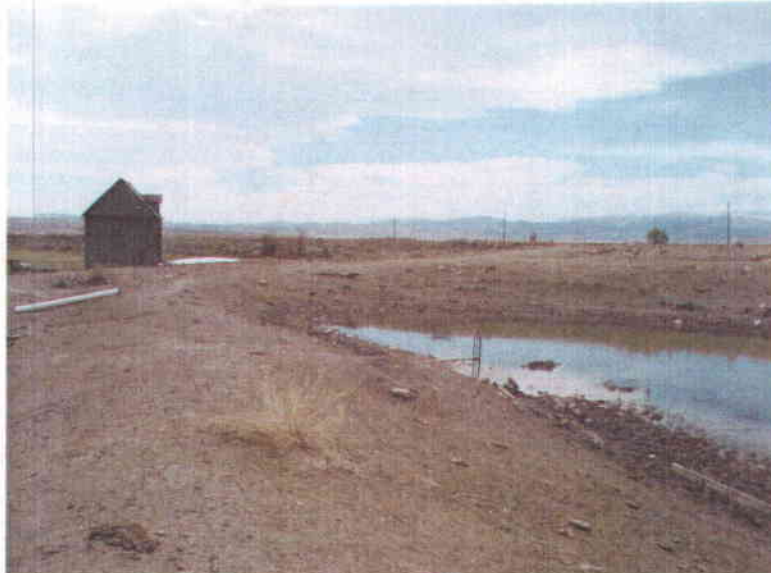
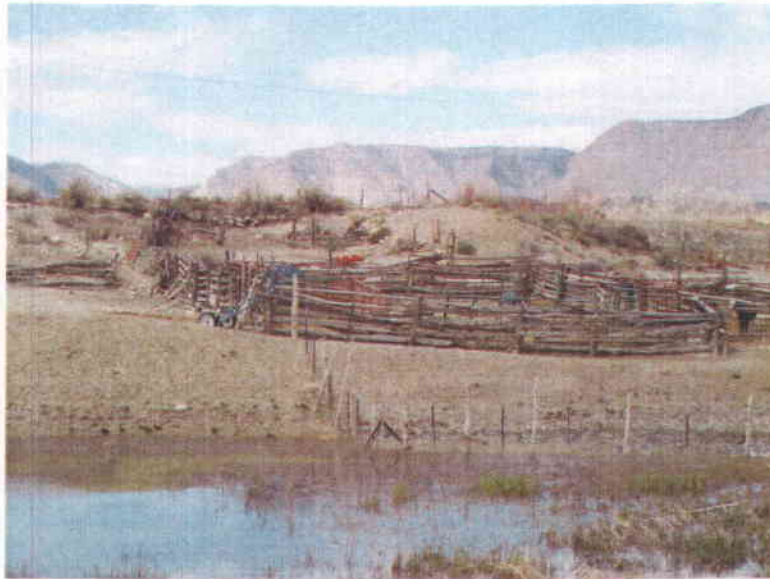
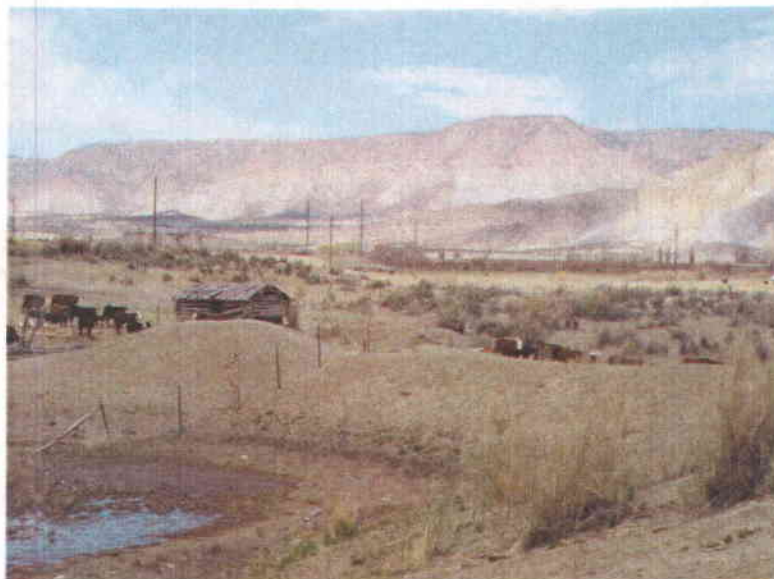
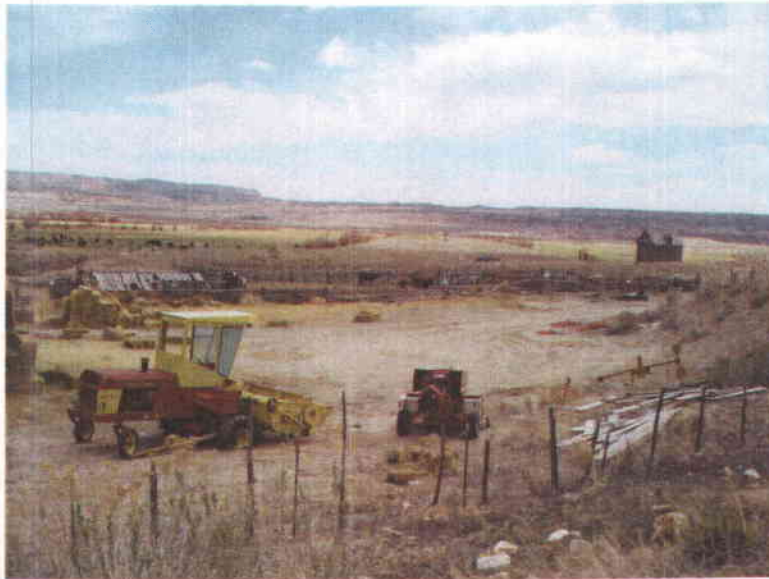
Feature 110. Corrals, Sheds, Barn, Pond, and Farm Land. The description of this feature has been updated from the Valley Engineering (1980) report. The corrals are constructed of unfinished and rough cut timbers as well as steel pipe fencing and are in good to fair condition. The sheds are constructed from rough cut logs and rough sawn boards and are in dilapidated condition. The roofs of the sheds have largely fallen apart. The barn is a two-story wood frame building in fair condition. It is founded on stacked rocks, which have started to fall over on the east side of the building. The pond measures approximately 300 feet long by 100 feet wide and has an earthen embankment that is approximately 10 feet tall on its east side. Irrigated fields of hay and grass covering an area of approximately 80 acres are located to the east and southeast of the corrals, barn, and pond.

Feature 110. Corrals, Sheds, Barn, Pond, and Farm Land. Looking east at barn.

Feature 110. Corrals, Sheds, Barn, Pond, and Farm Land. Looking west at barn.

Feature 110. Corrals, Sheds, Barn, Pond, and Farm Land. Looking west-southwest at foundation of barn.

Feature 110. Corrals, Sheds, Barn, Pond, and Farm Land. Looking south at pond and barn.

Feature 110. Corrals, Sheds, Barn, Pond, and Farm Land. Looking west across pond at corrals.

Feature 110. Corrals, Sheds, Barn, Pond, and Farm Land. Looking west at pond, corral, and shed.

Feature 110. Corrals, Sheds, Barn, Pond, and Farm Land. Looking southeast at corrals, shed, and farmland.

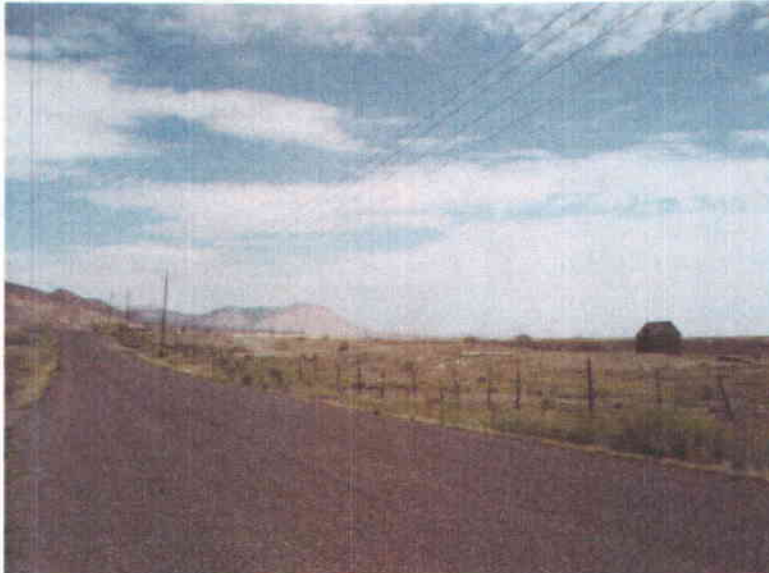
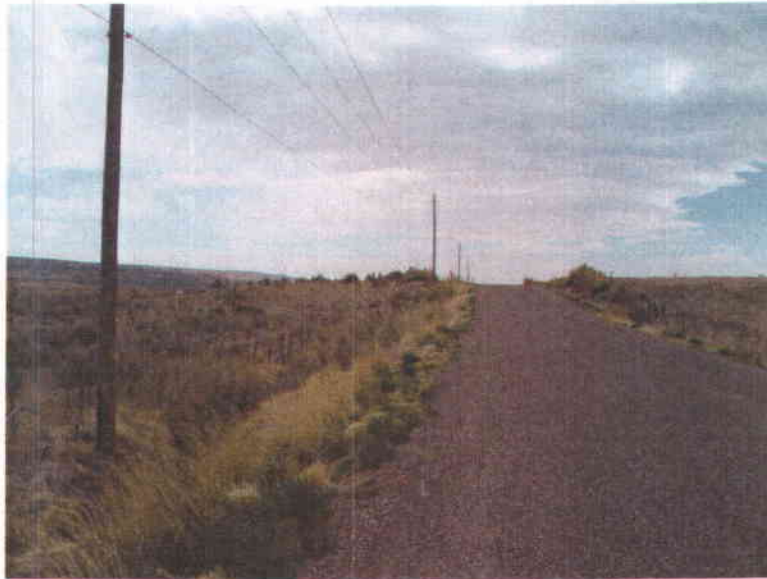
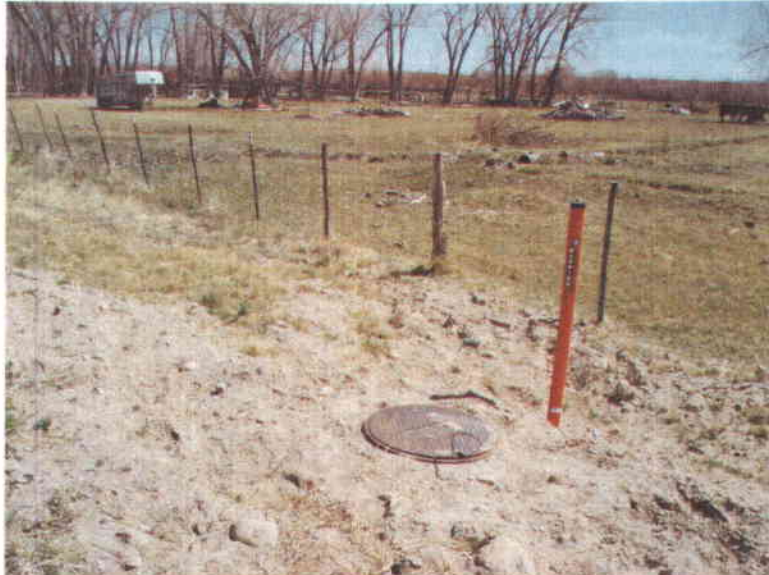
Feature 111. Gravel Road, Utility Power Lines, Telephone Lines, and Fence Lines. The description of this feature has been updated from the Valley Engineering (1980) report. The road

is surfaced with asphalt and is in good condition with few, if any cracks. An improved road surfaced with compacted gravel intersects the paved road from the west. The gravel road is in good condition. An overhead electric power line is located along the east side of the paved road and crosses over to run along the south side of the gravel road. Another overhead power line runs west to east along the north side of the gravel road, over the paved road, and across the adjacent pasture to the east. All of the power poles are in good condition, appear relatively plumb, and are about 40 feet tall. Orange markers that indicate the presence of a buried fiber optic cable are located along the north-south power pole alignment. Barbed wire fences run along both sides of the gravel and paved roads. The fences are in good to fair condition.

Feature 111. Road, Utility Power Lines, Telephone Lines, and Fence Lines. Looking north along the road. The barn in Feature 110 is visible in the right of the photo.

Feature 111. Road, Utility Power Lines, Telephone Lines, and Fence Lines. Looking south along the road. The barn in Feature 110 is visible in the center-left of the photo.

Feature 111. Road, Utility Power Lines, Telephone Lines, and Fence Lines. Looking northeast at a buried fiber optic cable manhole located below the power lines. Feature 113 is visible in the background.

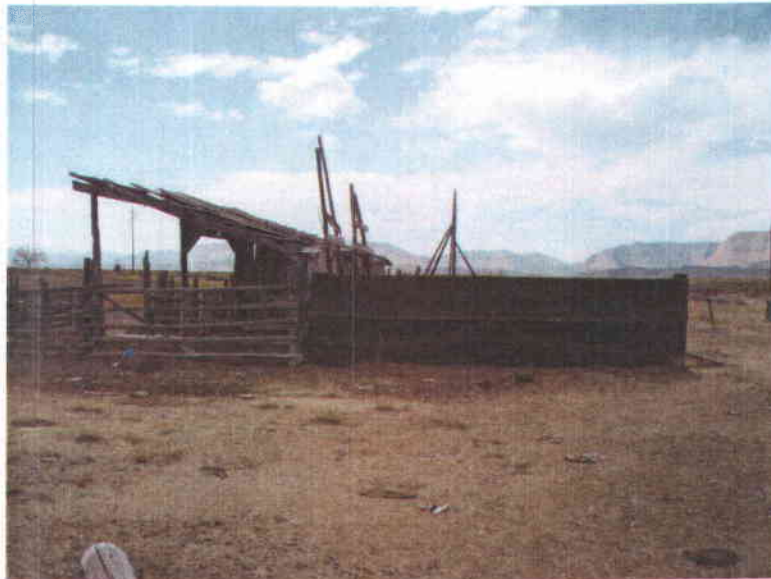
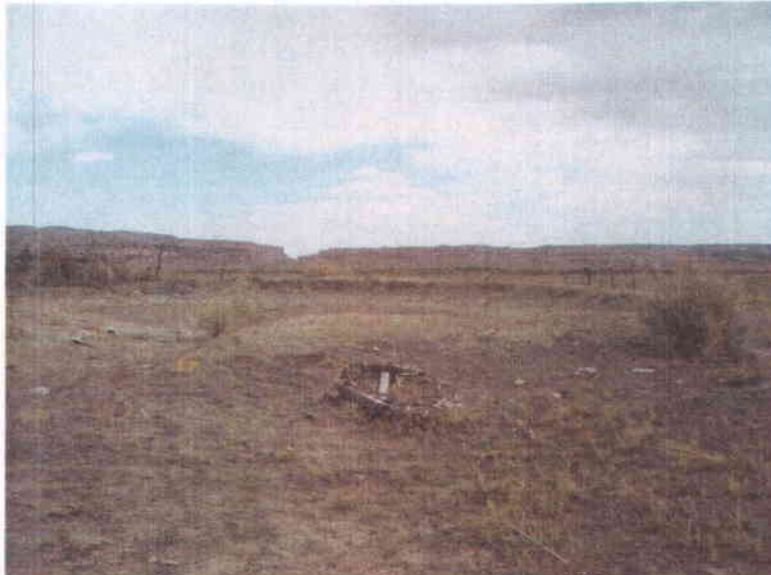
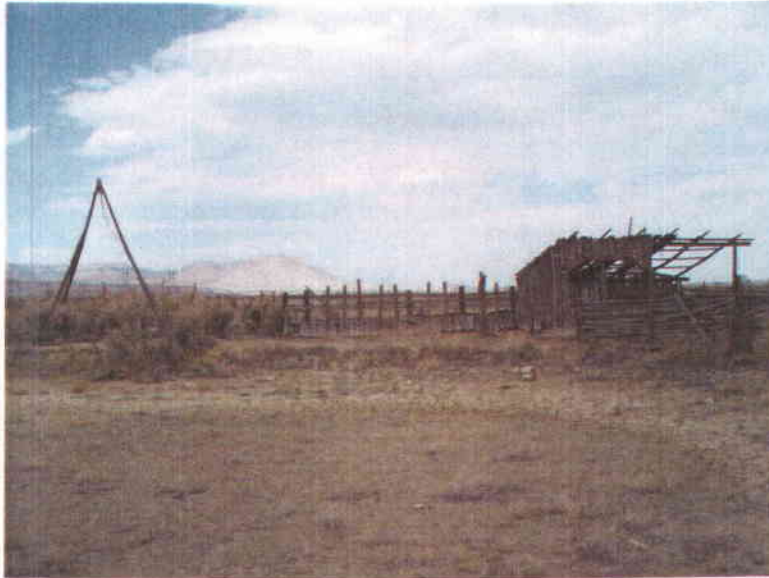
Feature 112. Corral. The description of this feature has been updated from the Valley Engineering (1980) report. This feature includes a corral, an animal shelter, remnants of a hay derrick, and two small ponds. The corral is constructed from rough-cut timbers, barbed wire, and conveyor belt material. It is in fair condition. The animal shelter is also constructed from rough-cut timber and is in dilapidated condition. Large sections of the roof are missing. The hay derrick is in fair to poor condition. The two ponds, which were empty during the Spring 2008 survey, are approximately 85 feet in diameter and have constructed with earthen embankments approximately 3 feet tall.

Feature 112. Corral. Looking west. The hay derrick is visible in the background.

Feature 112. Corral. Looking southeast at empty pond located east of corral.

Feature 112. Corral. Looking north at corral, shelter, hay derrick, and empty pond (in foreground).

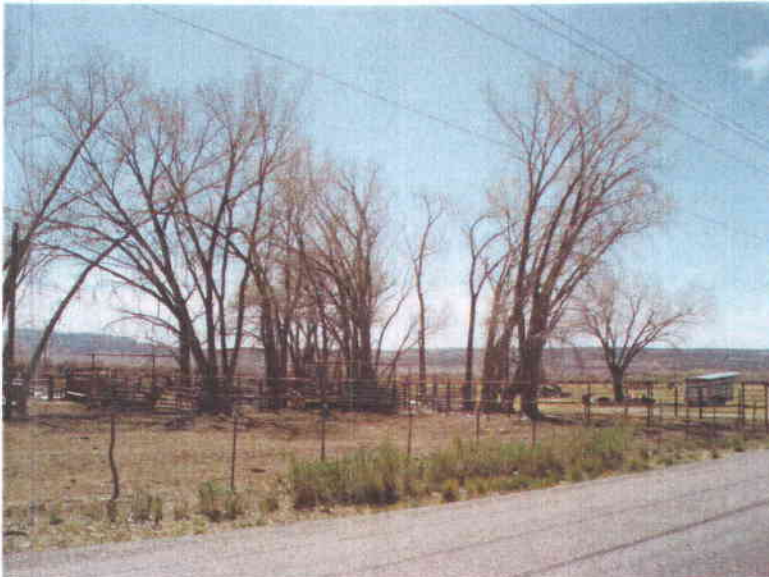
Feature 113. Corral. The description of this feature has been updated from the Valley Engineering (1980) report. The corral is constructed from both rough-cut timbers and painted metal tube fencing. The corral has been partitioned into several small areas. It is in good condition.

Feature 113. Corral. Looking southwest.

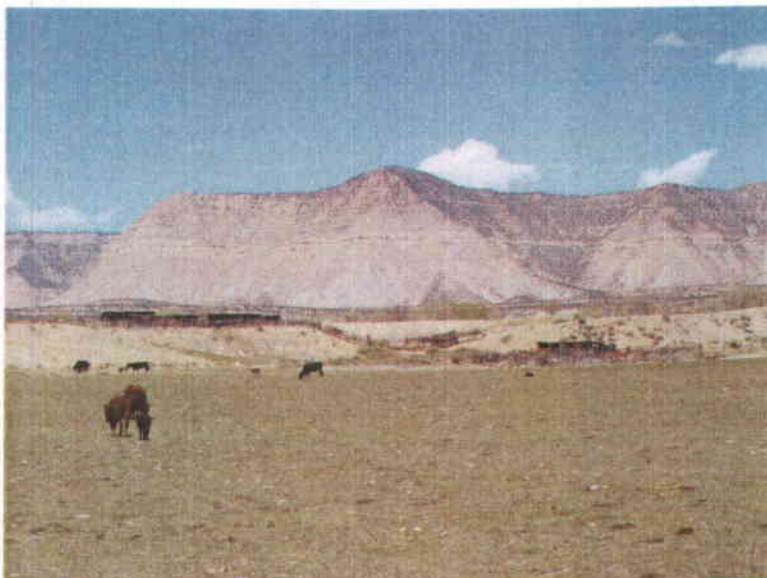
Feature 114. Corrals. The description of this feature has been updated from the Valley Engineering (1980) report. The corrals are constructed from rough-cut timbers which comprise the fence posts, fencing material, and sheltered areas. Hay was stored in one of the sheltered areas during the May 2008 survey. The corrals and shelters are in poor condition.

Feature 114. Corrals. Looking west. The corrals are in the distance. They were not directly accessible during the Spring 2008 survey due to the presence of livestock.

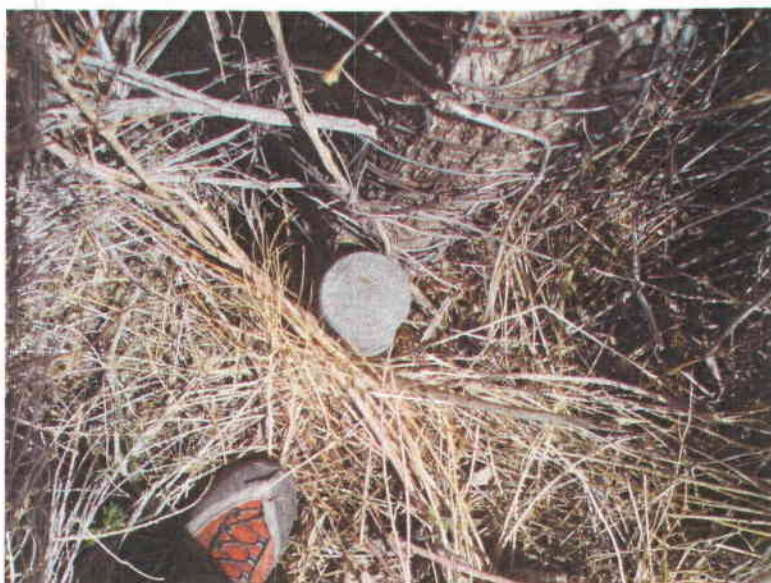
Feature 118. Section Corner Marker. This feature remains the same as described in the Valley Engineering (1980) report, which states the following: "This corner marker is located in Range 6 East Township 22 South. The marker is a metal cap on top of a short steel pipe. The marker is located at the intersection of Sections 20, 21, 28, and 29."

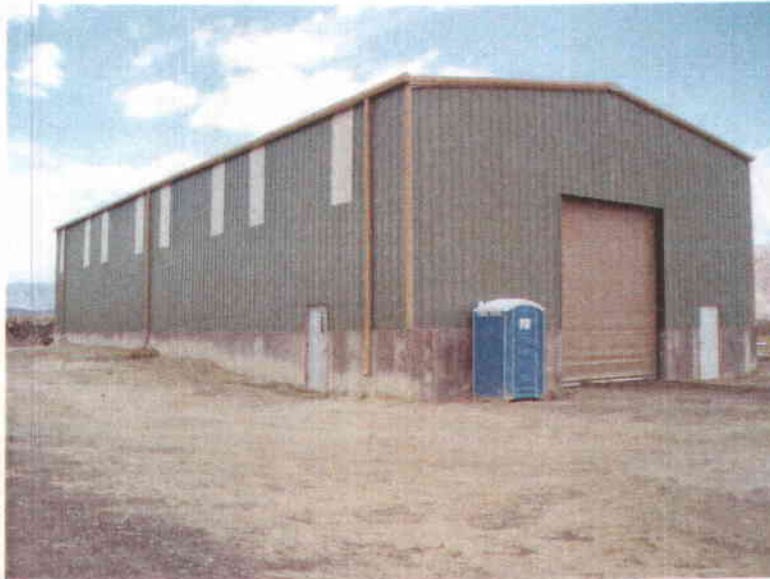
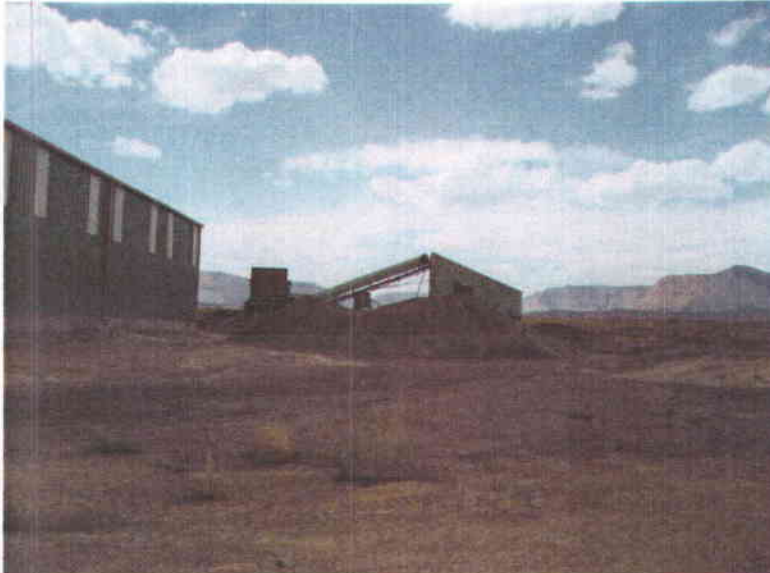
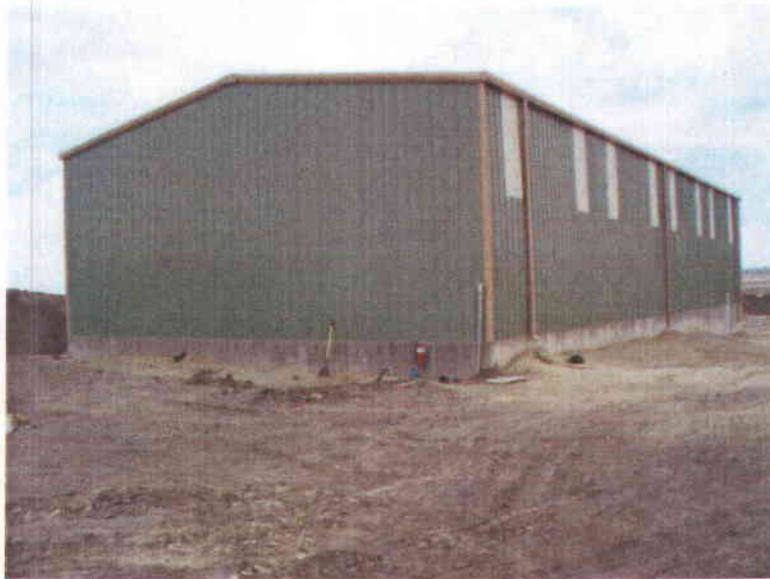
Feature 124. Shed. This feature was constructed after the Valley Engineering (1980) report was written. It is located about 1,000 feet north of the area scheduled for full extraction. The shed is built from corrugated metal with a concrete foundation and measures approximately 100 feet long by 40 feet wide by 30 feet tall. It is in excellent condition. A rock crusher is located adjacent to the shed on its northwest corner. An unimproved dirt road in fair condition leads from the graded gravel-surfaced road to the shed.

Feature 124. Shed. Looking west.

Feature 124. Shed. Looking southwest along side of shed at crusher.

Feature 124. Shed. Looking east.

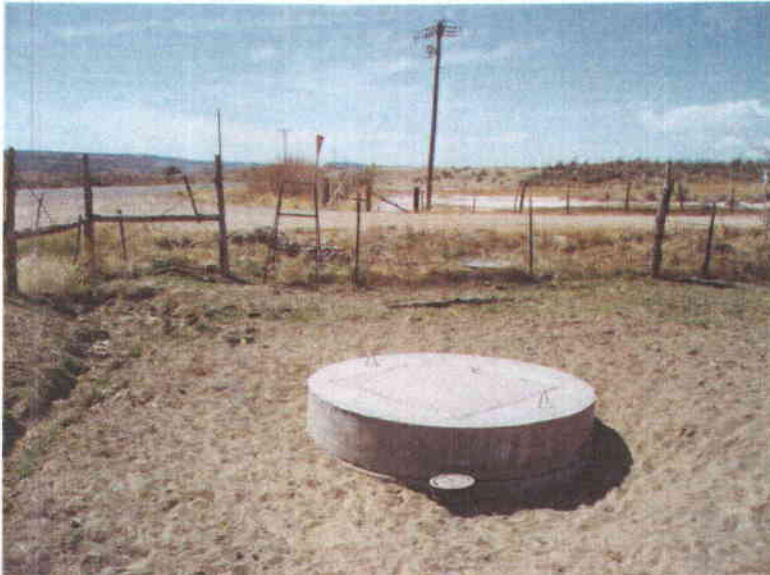
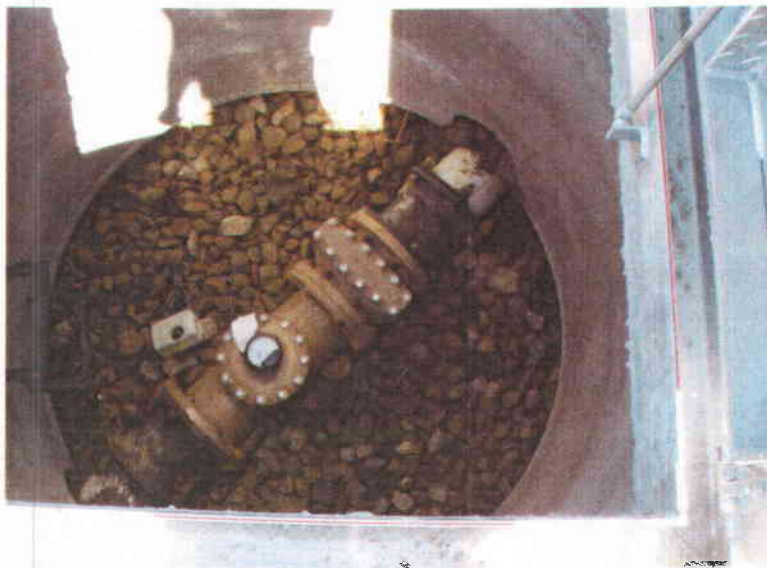
emergency shutoff valve that has been installed on the water line. The valve is intended to stop the flow of water in the line in the event that subsidence causes the pipe to rupture. The water line lies approximately three feet below the ground surface. A covered water meter is located adjacent to the manhole.

Feature 125. Water Line Manhole with Emergency Shutoff Valve. Looking south.

Feature 125. Water Line Manhole with Emergency Shutoff Valve. View into manhole looking at emergency shutoff valve.
